Burbank Water and Power

WILDFIRE MITIGATION PLAN

2022

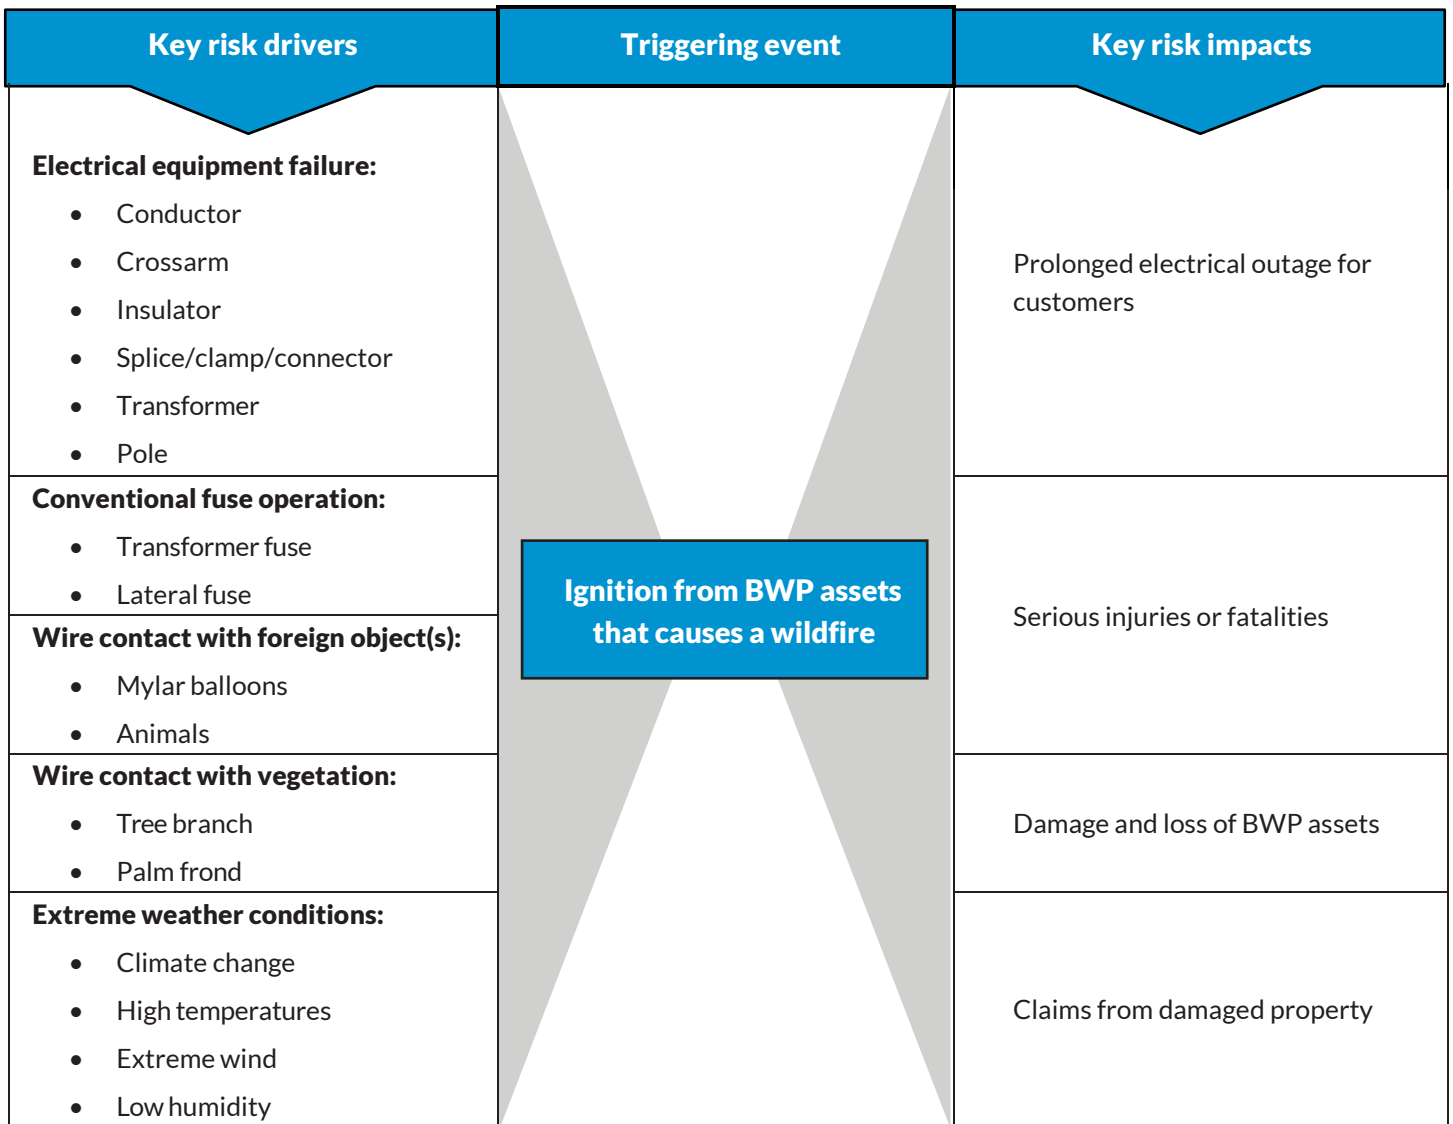
Figure 3 - BWP's wildfire risk bowtie

The risk of a vegetation ignition and potential for an uncontrollable wildfire caused by BWP electrical facilities is related to the type of vegetation (fuel bed) within its vicinity, the local/regional weather patterns, and the potential for a failure of BWP's equipment. For example, areas that include uninterrupted, natural (unmaintained) vegetation present a risk of ignition from ongoing operational activities or equipment failures. When the area also includes weather conditions that result in periodic high wind and low humidity, the wildfire risk is significantly enhanced. Both of these weather conditions can occur in BWP's Tier 2 HFTD area. A bow tie analysis was conducted to identify these risk drivers as well as their potential resulting impacts. Figure 3 provides the risk bow tie diagram, which summarizes the assessment process.

Risk drivers are important to identify because they are the primary ways in which BWP electrical facilities could result in a catastrophic wildfire. The center of the bow tie chart is the triggering event, which is an ignition caused by a BWP asset resulting in a catastrophic wildfire. During the wildfire threat assessment, five categories were identified as potential drivers for causing fire ignitions:

1. Electrical equipment failure;
2. Conventional fuse operation;
3. Wire contact with foreign object(s);
4. Wire contact with vegetation; and
5. Extreme weather conditions.

If one of the risk drivers listed above were to occur, resulting in a wildfire ignition caused by BWP electrical facilities, there could be potential consequences for BWP as presented on Figure 3.
